MARINE AND ESTUARINE ENVIRONMENTAL ASSESSMENT IN BRIDPORT, TASMANIA

Report to
Burbury Consulting
March, 2019

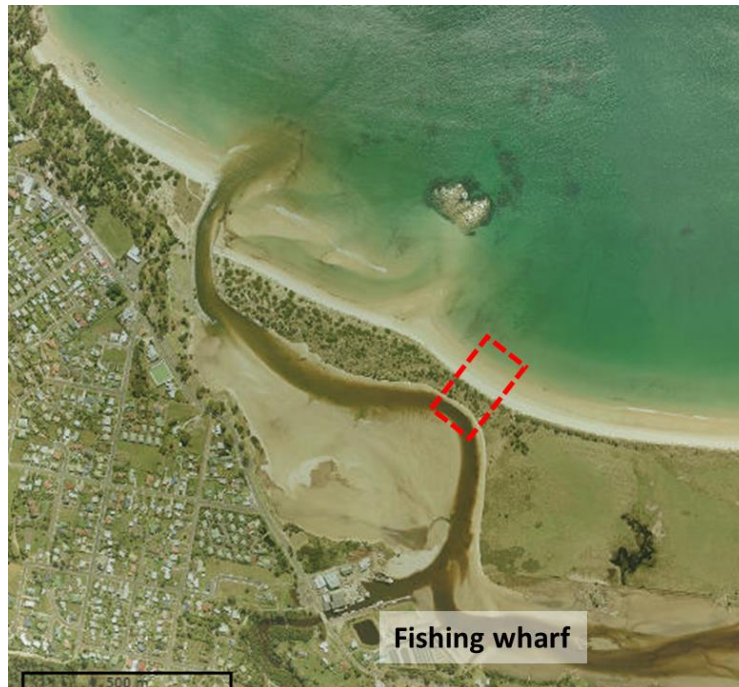
Figure 2 Potential zone for Hurst Creek rivermouth adjustment

Burbury Consulting are investigating options to improve marina facilities and vessel operations within Bridport, north-eastern Tasmania. One option Burbury Consulting are considering, to facilitate improved vessel operations includes an adjustment of the Hurst Creek rivermouth by re-routing Hurst Creek through the sand dunes adjacent to the fisheries wharf (Figure 2).

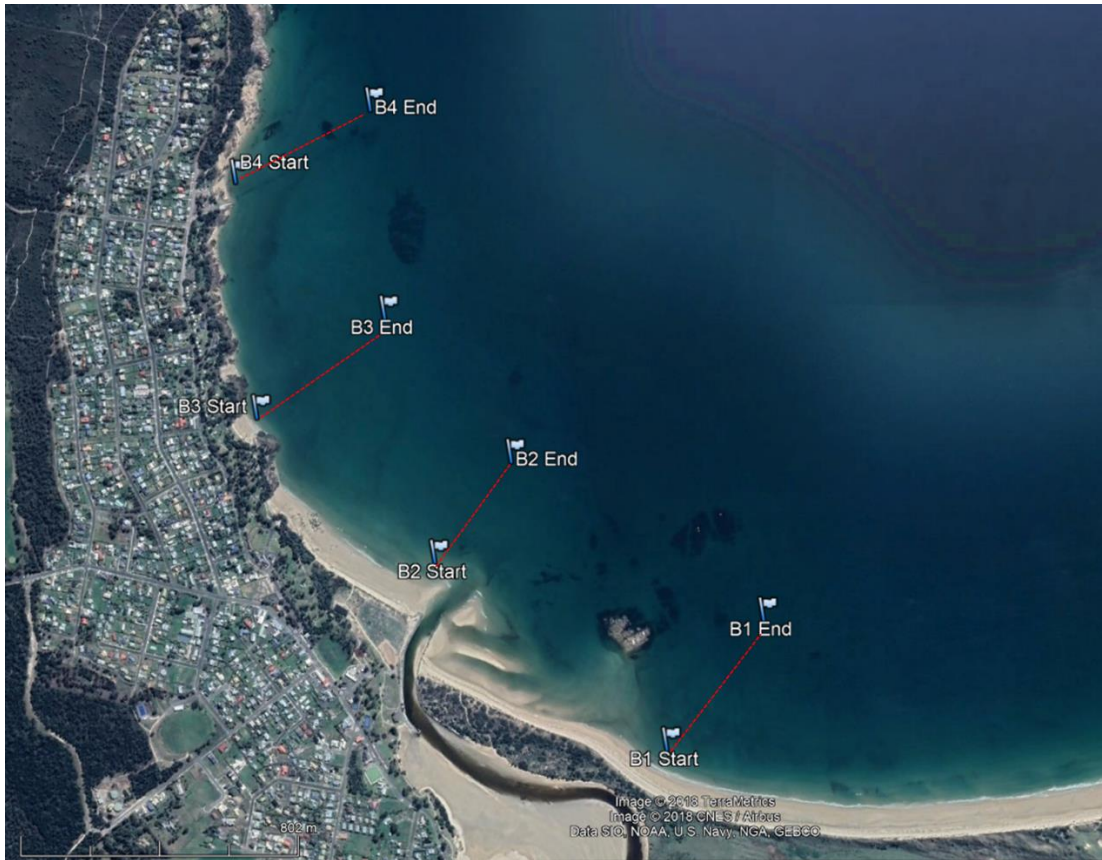
Figure 3 Location of video tows

Video tow transects were conducted within the subtidal zone of Anderson Bay on the 8th of November 2018 (see Appendix 2 for positional information). Footage was captured to obtain information on habitat types, habitat viscosity and benthic features. Four video tows were conducted throughout the study area, from the dunes adjacent to Hurst Creek to the old-pier boat ramp (Figure 3). Transects commenced at approximately 1 m depth at the shoreline, and extended, perpendicular to the shoreline for approximately 100 m.

Video footage was stamped with date, time and positional information. Towed video footage was captured with a Scielex single CCD camera recording to a portable hard drive Archos PMA 400 unit at resolution of 440Tv lines and 512 x 582 pixels and is available as separate AVI files (available on request from Marine Solutions).

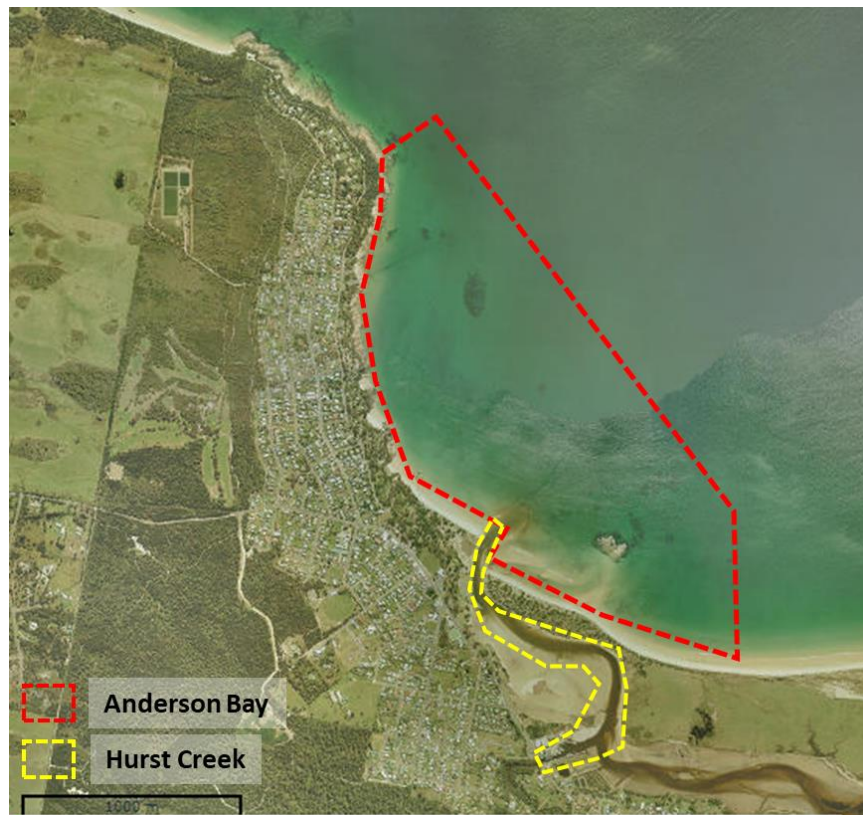
Figure 8 Bathymetric mapping zones, including Anderson Bay (denoted in red) and Hurst Creek (denoted in yellow)

Two zones were mapped within the study area, including 1) Anderson Bay and 2) Hurst Creek (Figure 8). A 3 km stretch of shoreline was mapped within Anderson Bay, extending to 1 km offshore at the furthest extent. Anderson Bay was mapped from the shoreline (0.5 m depth AHD) to approximately 10 m depth AHD. Approximately 1.5 km of Hurst Creek was mapped from the rivermouth to the fishery wharf upstream.

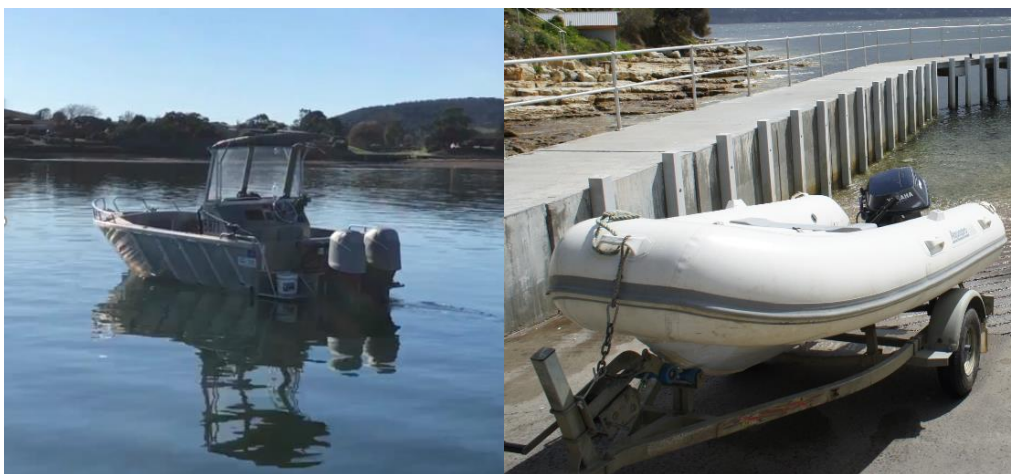
Figure 9 Vessels used for bathymetric mapping, including “The Second Solution” (left) and “The Small Solution”

Bathymetric mapping was conducted using two vessels: “The Second Solution” and “The Small Solution” (Figure 9). Anderson Bay was mapped using “The Second Solution” using a CHIRP enabled broadband sounder Simrad NSS9 evo2 chart plotter. GPS position and water depth were logged every 2 seconds to *Seabed Mapper* run on a laptop computer. Due to restrictive depths, Hurst Creek was mapped in our

smaller vessel, “The Small Solution” using a CHIRP enabled broadband sounder Garmin EchoMAP plotter, also logging GPS positions and water depth every two seconds.

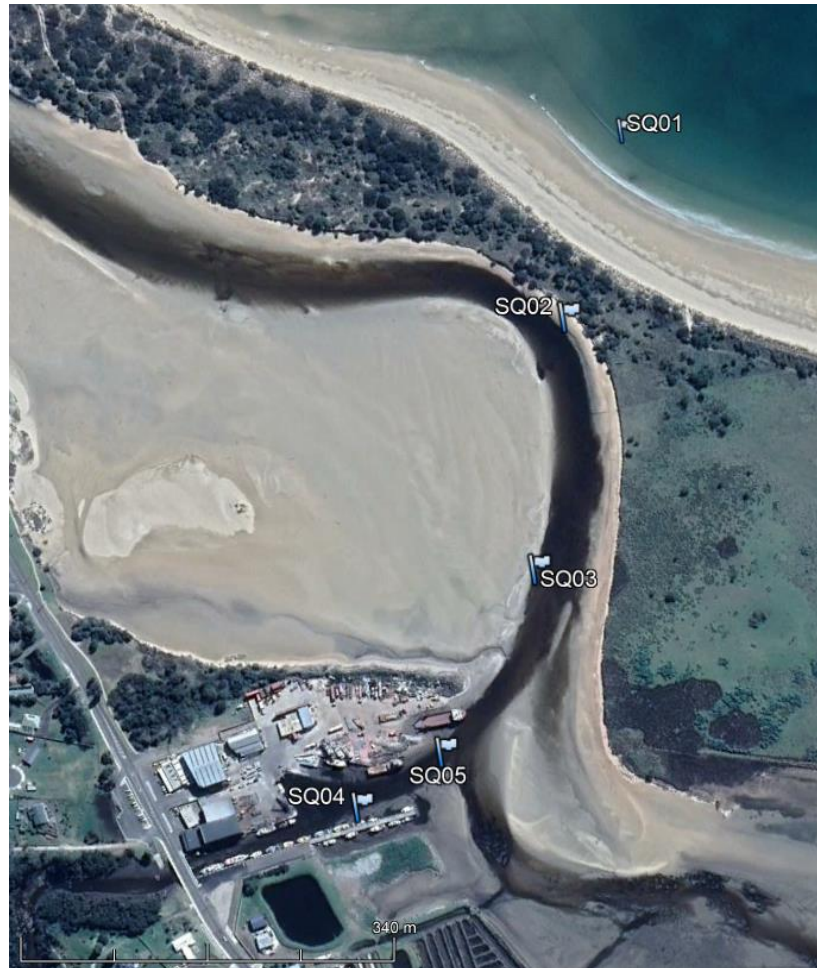
Figure 12 Sediment sample sites throughout Hurst Creek and Anderson Bay for jet probing, ASS testing, contaminant testing and particle size testing.

To characterise the sediments, and subsequent environmental risk of dredging at Bridport, sediments were sampled at a total of 5 sampling sites (see Figure 12 and Appendix 2).

Sediment depth information was collected from 5 jet probe points along the proposed dredging alignment (Figure 12). Jet probing found variable sediment depth along the alignment, with hard bedrock refusal found at site SQ03. Sediment depth was over 2 m at sites SQ02 and SQ04, with depth

likely also greater than 1.8 m at SQ01 (Table 3). Jet probing was not completed at site SQ05 due to an incoming tide.

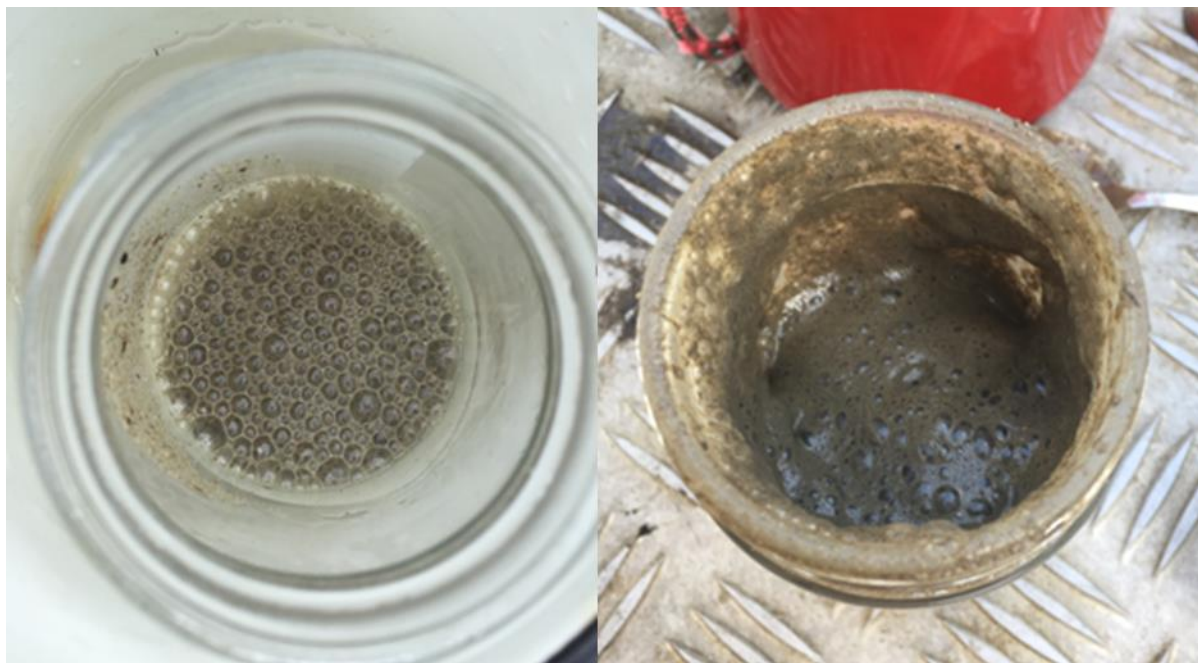
Figure 13 The early stages of pH_{FOX} reaction at site 3 (left) and a vigorous pH_{FOX} reaction foaming over the jar at site 4 (right)

Field tests from cores sampled (SQ02, SQ03, SQ04 top and SQ04 bottom) indicated a strong likelihood of ASS. Samples showed a reduction in pH of >1 unit after the addition of hydrogen peroxide (Table 4). This was accompanied by moderate to vigorous reactions. All samples showed evidence of fizzing and bubbling. After 2-3 minutes of gentle heating samples from sites SQ02 and SQ04 top and bottom continued to produce strong to vigorous reactions that foamed and bubbled over the tops of the 250ml jars that were used for the testing (**Error! Reference source not found.**). Sulphur odor was evident for cores from sites SQ02, SQ03 and SQ04.

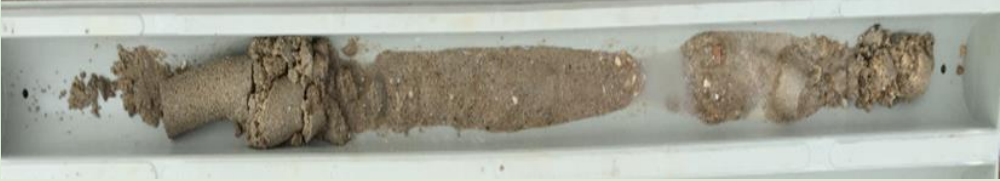
Table 4 AASS/PASS field testing results from sediment cores collected at Bridport

Core ID	Photo	pH _F	pH _{FOX}	ΔpH	Reaction
SQ01

No field test	No field test	N/A	N/A
SQ02

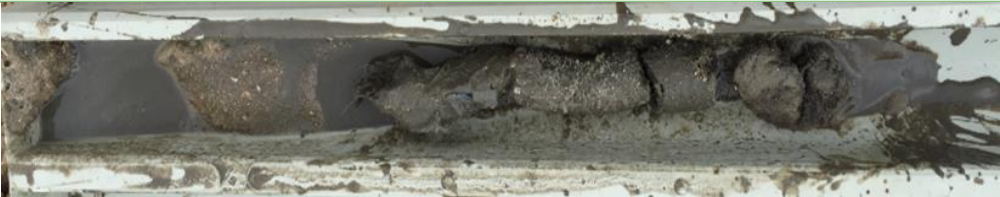
7.7	5.8	1.9	3 – strong reaction
SQ03

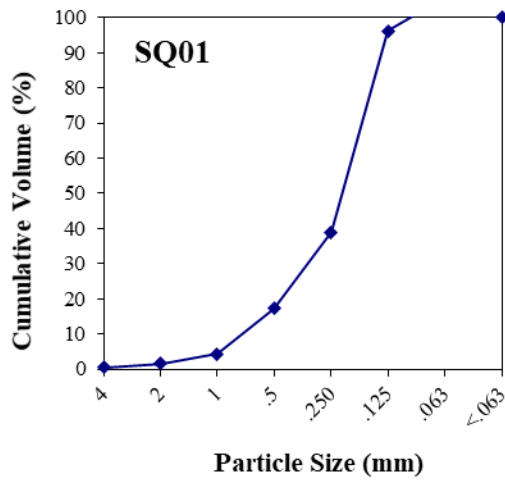
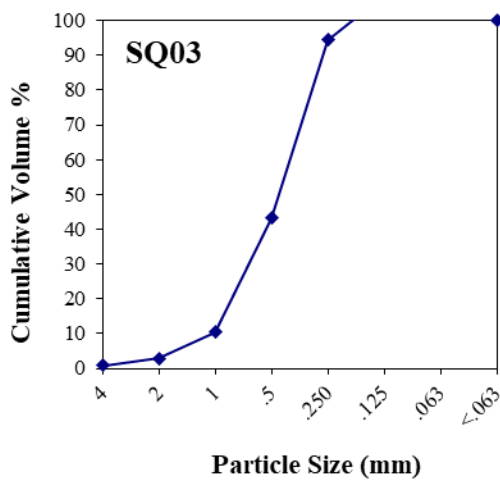
Figure 14 Particle size distribution of sediments at the proposed development area

sediment fraction (4 mm) and working down to the finest (63 µm). The volume of sediment measured in the measuring cylinder was recorded for each sieve size. The sediment fraction <63 µm was assumed to be the total volume of the sample minus the combined volume of all other size classes.

Analysis indicated that sediments at the proposed development site mostly consisted of medium grained particles between 0.5mm – 0.125mm in the surface layer (Figure 14). This reflects the mobile nature of the surface sediments due to strong tidal movements throughout Hurst Creek and along the oceanic beach. Sites SQ04 and SQ05 showed higher proportions of fine particles (0.063mm). These sites are located near the fisheries wharf and would receive less tidal influence than the fast-flowing creek sites, and reflective of silt depositional areas.
